Farnsfield

An Appraisal of the
Character & Appearance of the Conservation Area

NEWARK &
SHERWOOD
DISTRICT COUNCIL
2000

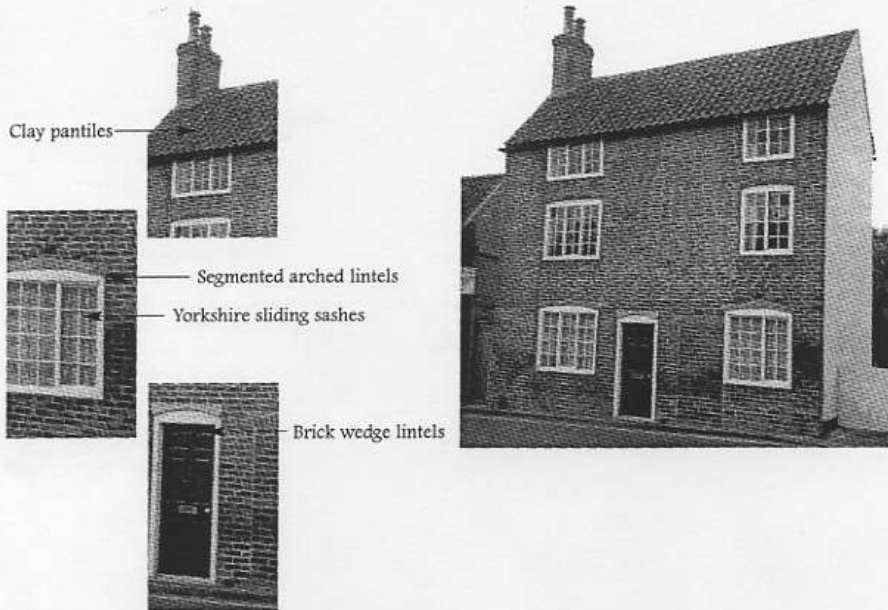
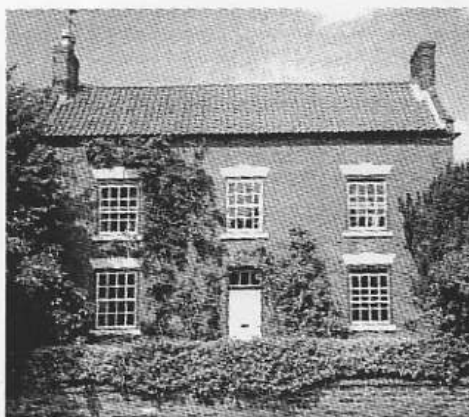
19. Stone sills. Georgian windows, particularly in rural buildings, often have no sills at all. In these cases, small plain lead flashings may be added if necessary to protect the exposed brickwork edge in an unobtrusive manner. Where stone sills are used they are usually one or two courses of brick work deep. They are often painted, which gives protection from the weather.

20. Walls and gateposts. Most boundary walls in Farnsfield are of brick, often with brick copings of half-round section or "saddleback" section. Some are built of stone usually with half-round copings. There are examples of brick walls with stone copings and gatepiers.
