Upton

An Appraisal of the
Character & Appearance
of the Conservation Area

NEWARK &
SHERWOOD
DISTRICT COUNCIL
1999

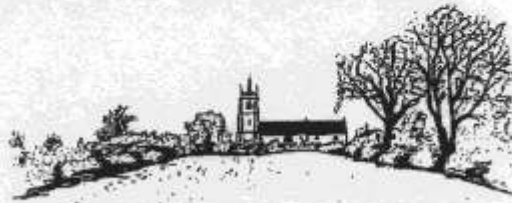
17. Long, narrow fields behind the houses and farms on the main street are still much in evidence, originally formed by the enclosure of ridge and furrow ploughlands. Some of these ploughlands, preserved by their conversion to permanent pasture, can still be seen in a field north of Corner Farm recently planted as an orchard. Many of the hedgerows follow a curved line, like a reversed S, thought to have been caused by manoeuvring of the plough teams.

18. The field pattern around the village respects the natural contours of the ground, as the groups of ridge and furrow ploughlands from which these fields have evolved were deliberately arranged to facilitate natural drainage. Many of the public footpaths and subsidiary lanes which thread through the village run alongside old-established field boundaries. The main road also respects the natural lie of the land, and the total lack of any imposed street planning is a strong characteristic of the village. The direct relationship between the natural terrain and the layout of the village is essential to the village's sense of place and rural character.

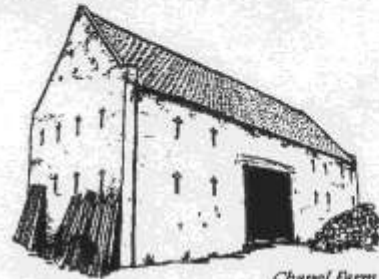
Chapel Farm

- b. *Farm buildings.* Only two working farms remain in the village, namely Redlands Farm and Chapel Farm, but a large proportion of farm buildings remain as reminders of the past agricultural economy of the village (see appendix 2).

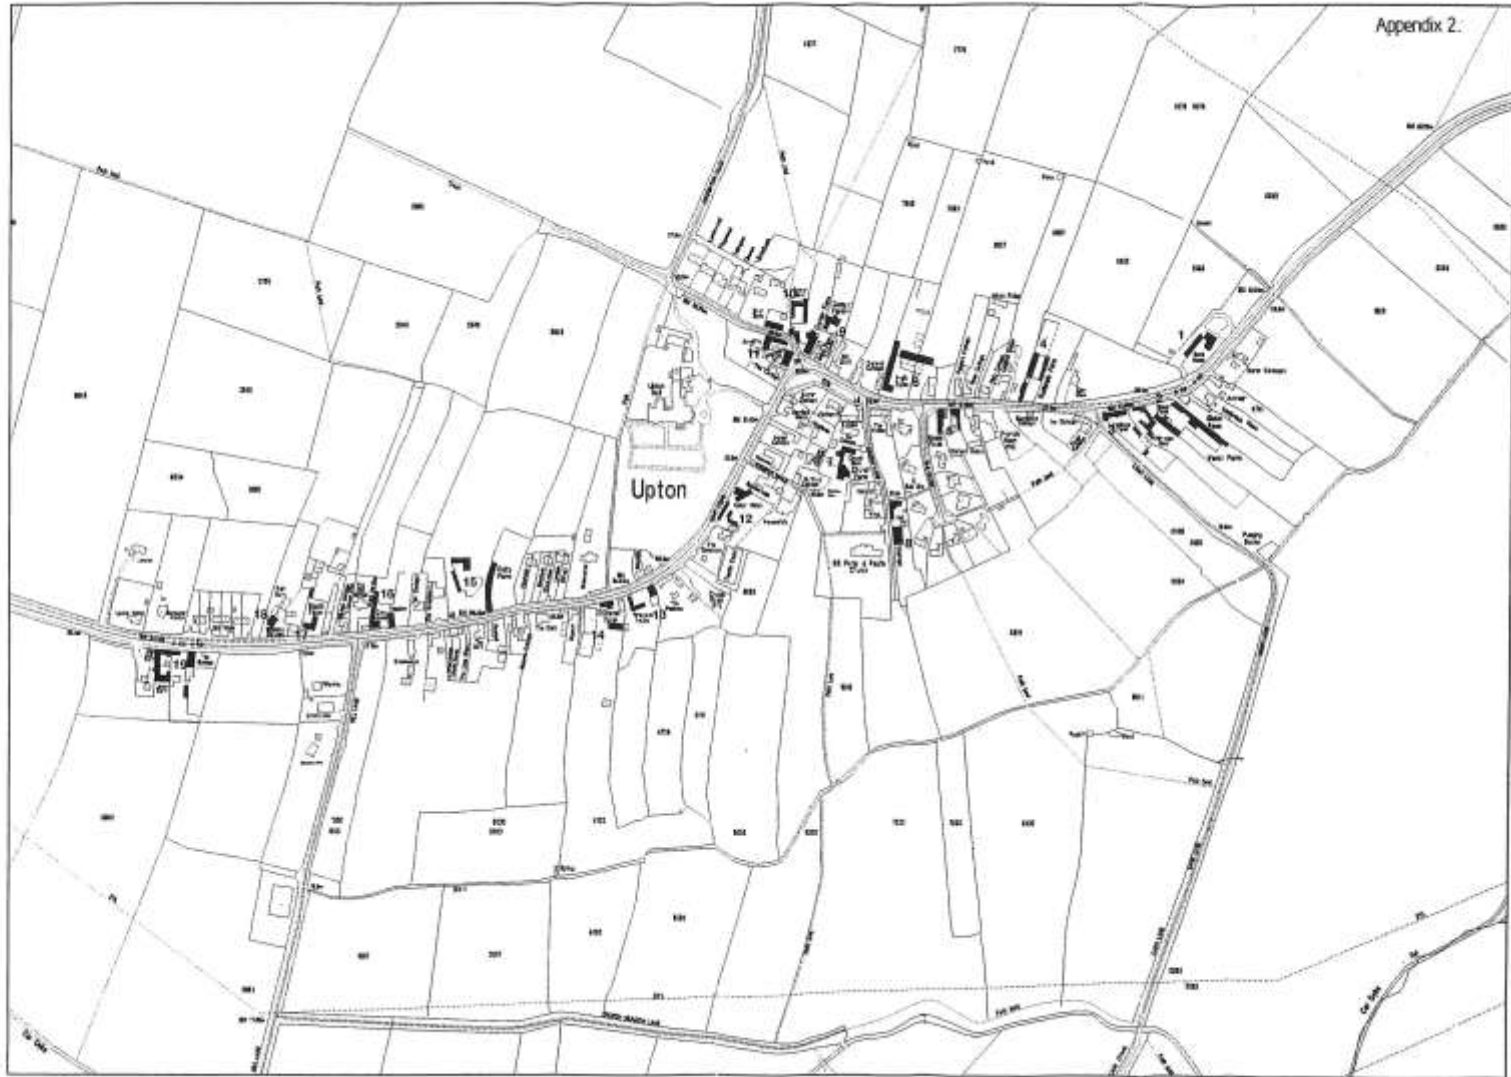
Appendix 2. Farmsteads and Farm Buildings which contribute positively to the character of the Upton Conservation Area. *(see attached plan)*

1. **North House.**
2. **Manor Farm.** A former outbuilding alongside the road has been demolished.
3. **Heritage Farm.** The outbuildings are now mostly converted to residential use and occupied separately as "Heritage Barn".

4. **Redlands Farm.** Still a working farm.
5. **Home Farm.**
6. **High Farm.**
7. **Church Farm.** The outbuildings are now converted to residential use and occupied separately as "Church Barn".

8. **The Old Vicarage.** The barn here, which retains fragments of its original timber framing, was converted to a parish room by the Rev. Percy Leeds.

9. **Daisy Farm.** This was a barn with attached buildings and small cottage, but the barn is now converted to form part of the residential accommodation.

10. **Corner Farm.** The outbuildings are now converted to multiple residential use and occupied separately.
11. **Warriners Cottage.** Part of the outbuildings are now converted to residential use and occupied separately as "Arncliffe Cottage".

12. **Upton Manor.**
13. **Pensylane House.**
14. **Chapel Farm.** Still a working farm.
15. **Dairy Farm.** The listed buildings, forming the western part of this group, have recently been partially rebuilt and converted to residential use, and are occupied separately.

16. **Crop House.** The eastern outbuilding here was converted to residential use around 1972 and is occupied separately. It is known as "Ysgubor" (Welsh, =barn).

17. **South Farm.**
18. **High Barn.** Converted and extended for residential use. An elliptical stone plaque on the building reads "J.S. 1812".
19. **The Grange.** Permission was given for the conversion of the western outbuildings here into two dwellings in March 1985. They are not considered to be listed as curtilage buildings, as the Grange was not listed until September 1985.

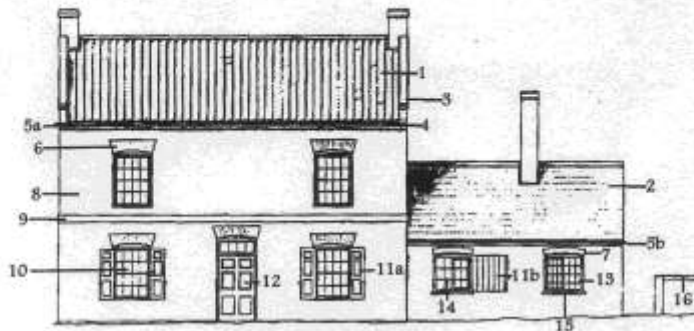
5a. Dentilled eaves cornices

and
5b. Sawtooth eaves cornices

These are the most common types of cornice in the district, but there are many variations. Heavy cornices with a combination of both types are sometimes found in the District, particularly on buildings erected before c1800. Roof verges were usually plain. Eaves cornices were seldom used on verges before the Victorian period, and the current trend for elaborate brick work on roof verges can look overbearing on modest housing schemes.

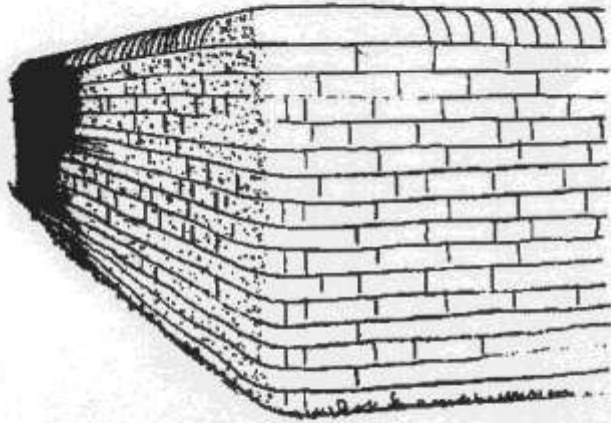
16. Walls and gateposts. Most boundary walls at Upton are of brick, often with brick copings of half-round section:

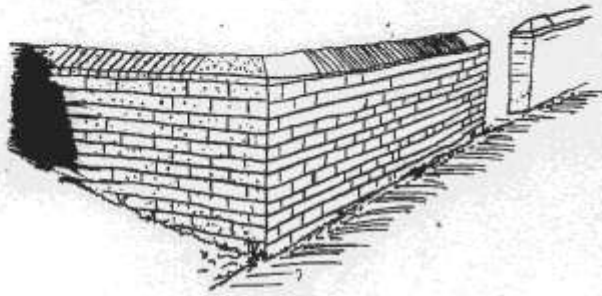
or "saddleback" section:

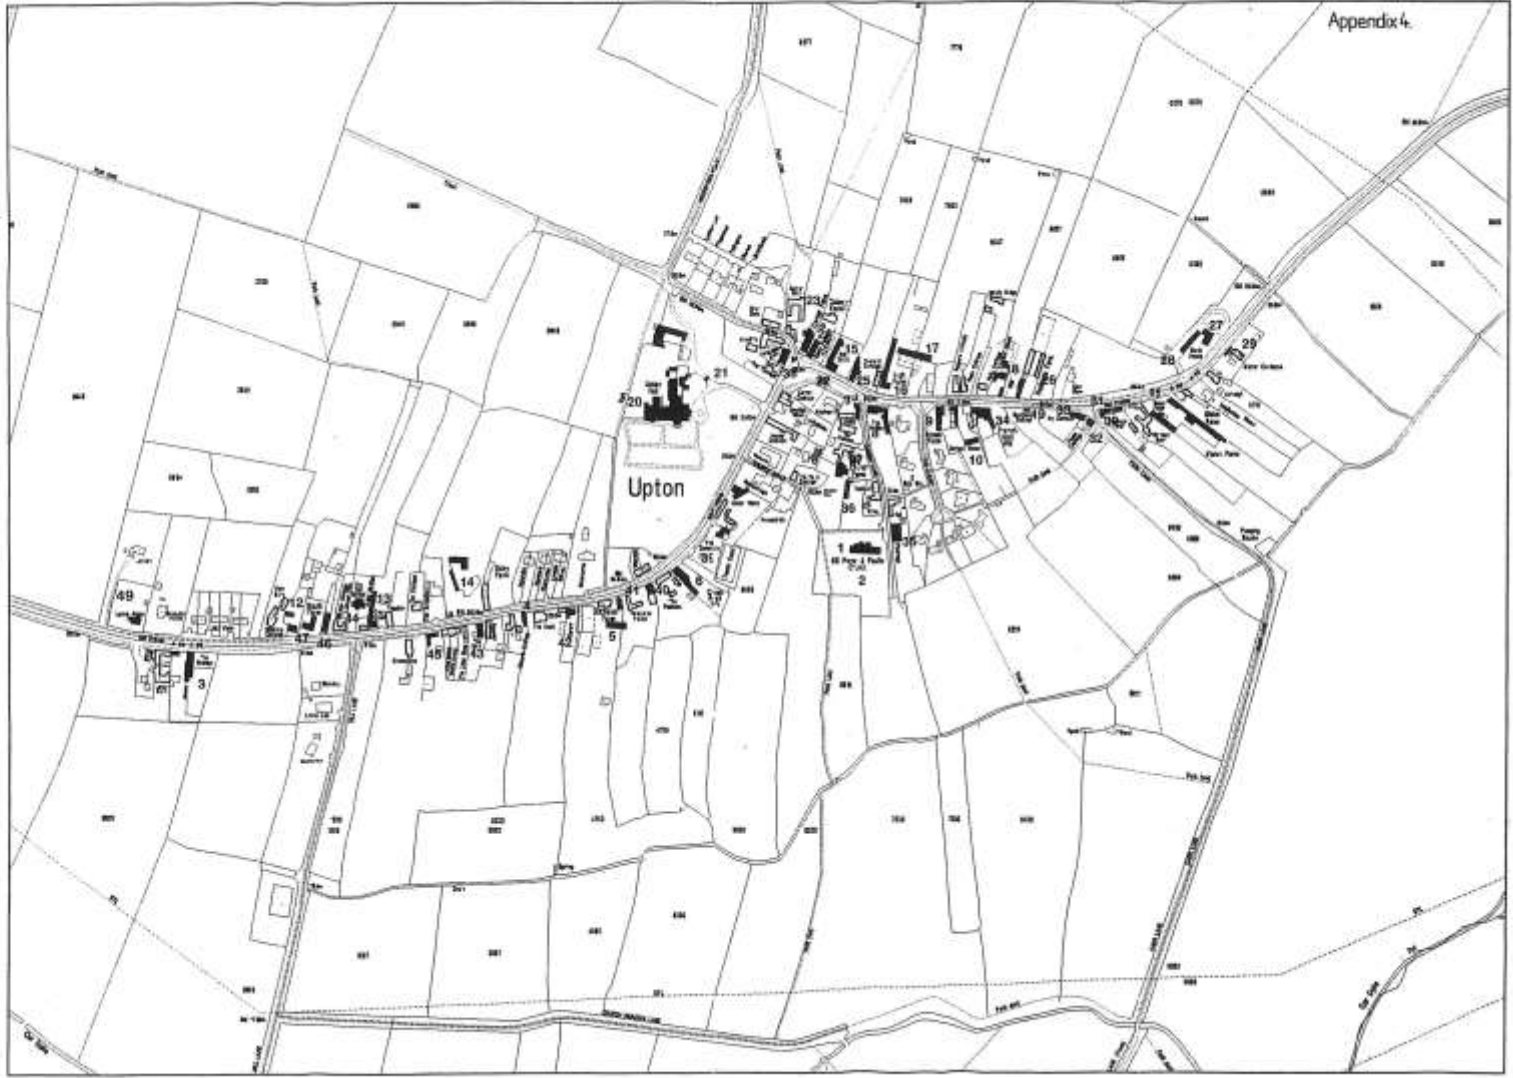
Appendix 4. Listed buildings and other significant buildings *(see attached plan)*

There are currently (June 1997) 22 listed buildings in the conservation area, comprising the following:

1. Church of St. Peter and St. Paul. Grade 1.
2. Group of five headstones south of the parish church. Grade 2.
3. Upton Grange. Grade 2.
4. Masons Cottage (listed as Green Door Cottage). Grade 2.

5. Barn at Chapel Farm. Grade 2.
6. The Cross Keys Inn. Grade 2.
7. The Old Post Office. Grade 2.
8. The Hollies and adjoining boundary wall. Grade 2.
9. Home Farm House, with adjoining cottages and water pump. Grade 2.

10. Orchard House. Grade 2.
11. Manor Farm House. Grade 2.
12. Wisteria Cottage. Grade 2.
13. Crop House. Grade 2.
14. Farm buildings at Dairy Farm. Grade 2. Now called "The Hay Barn".

15. Hall Croft. Grade 2.
16. High Farm House. Grade 2.
17. Barns and stable at High Farm House. Grade 2.
18. Candant Cottage (listed as Candant House). Grade 2. (The property now known as Candant House was built at the rear of this property in 1992.)

19. Babthorpe Cottage. Grade 2.
20. Upton Hall. Grade 2*.
21. Gateway at Upton Hall. Grade 2.
22. K6 Telephone Kiosk. Grade 2.
