Bulcote

An Appraisal of the
Character & Appearance
of the Conservation Area

NEWARK &
SHERWOOD
DISTRICT COUNCIL

2001

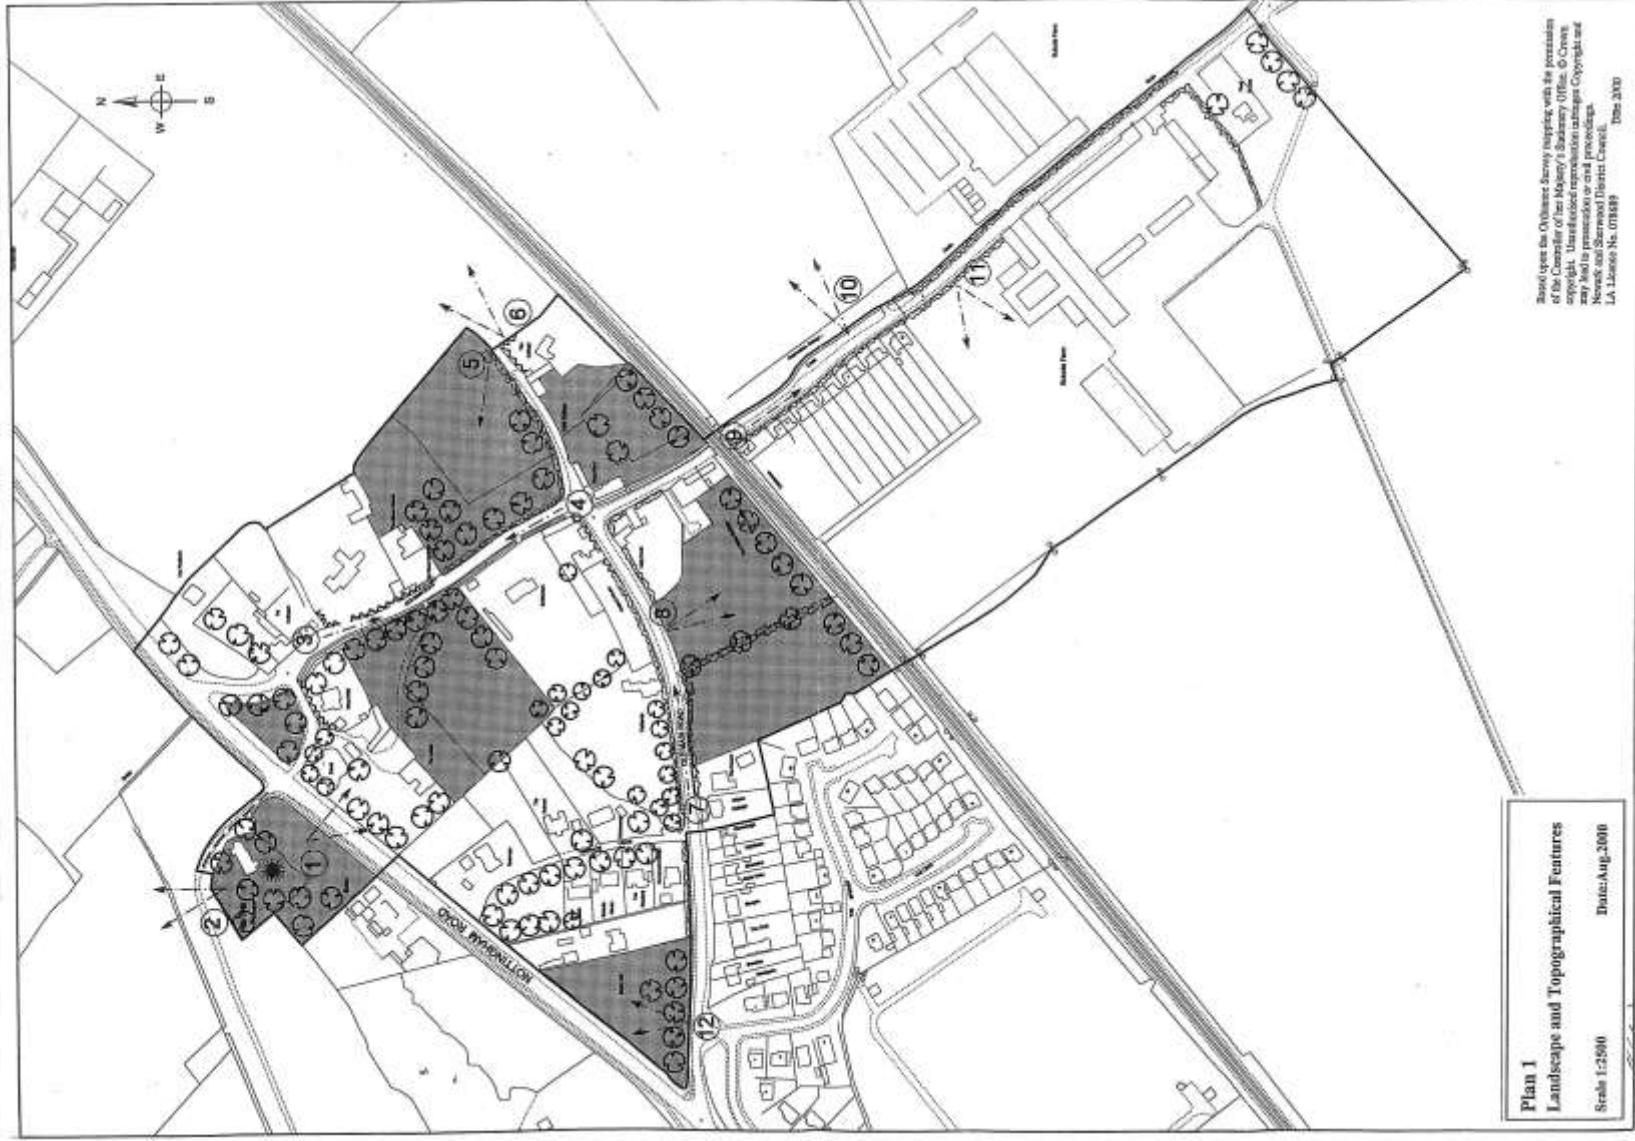
Plan 1
Landscape and Topographical Features
 Scale 1:2500 Date: Aug. 2000

1. Excellent viewpoint of most of the conservation area, with the Lodge in the near view and glimpses through the trees of the rest of the village with Bulcote Farm in the far distance.

2. Views of open countryside up the hillside behind the church
3. Enclosed feel to the view as the lane gently curves between the high boundary wall of Manor stables and the hedges on the other side.

4. View unfolds along the gently curving hedge lined lane
5. Glimpses through the trees of the Manor House
6. View of open countryside
7. View along hedge lined lane, the trees in the grounds of Oaklands are prominent.

8. Long distance views over open field and the railway line of Bulcote Farm in the far distance with the chimney stacks of Corporation Cottages being prominent.

9. Straight view down to Bulcote Farm in the far distance.
10. Views of open countryside.
11. Views of open countryside.
12. Glimpses through the trees of the church.

24. The important areas of trees, open areas and hedgerows which contribute significantly to the special character of the conservation area are outlined below and shown on plan 1.

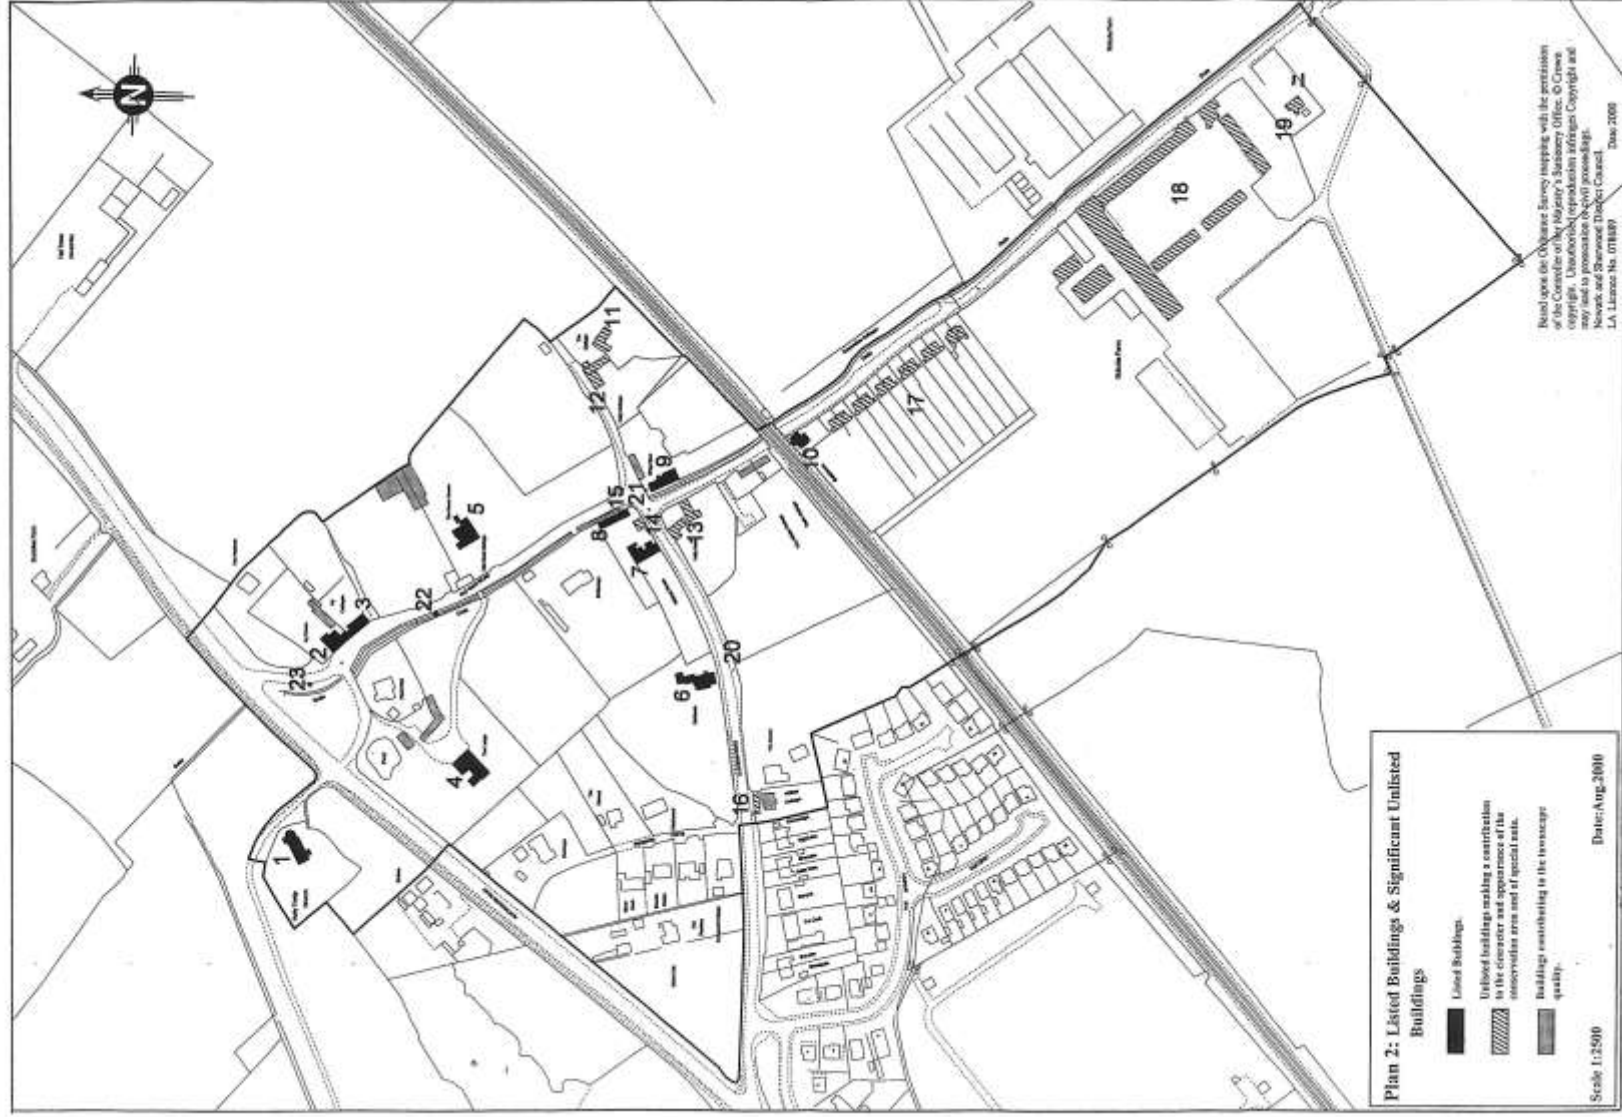
Plan 2: Listed Buildings & Significant Unlisted Buildings

The buildings shaded on plan 2 are buildings which contribute to the townscape quality but are not of significant interest to be worthy of particular note. They are usually altered buildings where the original character and appearance has been changed.

28. The special nature of the buildings in Bulcote is reflected in the number of buildings which are listed as buildings of special architectural or historic interest. These are identified and described in detail in appendix 2 and plan 2.

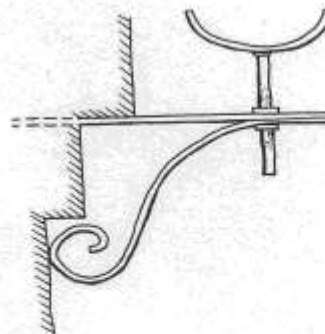
5. **Wrought iron gutter brackets** with cast iron gutters and downpipes.

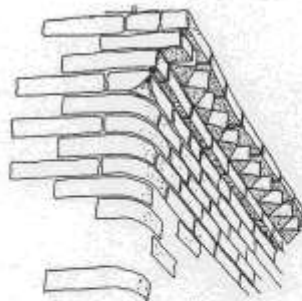
7. **Sawtooth eaves cornices.**

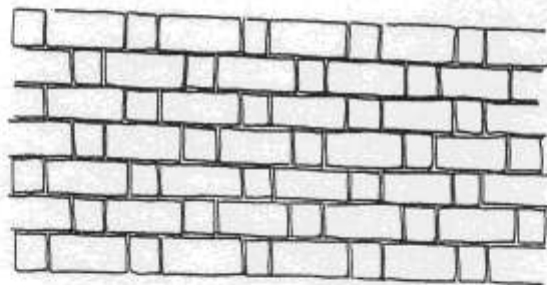
12. **Flemish bond brickwork.** Flemish bond brickwork, with alternate longways ("stretchers") and endways ("headers") bricks in each course, was often used for house fronts, often in conjunction with a pale superior quality mortar. The mortar joints were sometimes "penny struck", i.e. grooved down the middle to give a sharper and crisper appearance. Flemish bond brickwork was expensive to lay, so cheaper bonding patterns with less headers were usual on side and rear elevations. The bricks and mortar would often be less fine than on the front, and the pointing might be less carefully finished.
