Eakring

An Appraisal of the
Character & Appearance
of the Conservation Area

NEWARK &
SHERWOOD
DISTRICT COUNCIL

2001

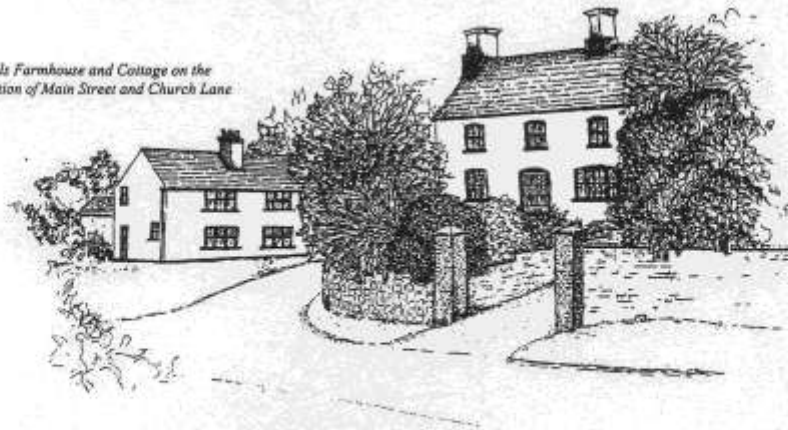
Ryalls Farmhouse and Cottage on the junction of Main Street and Church Lane

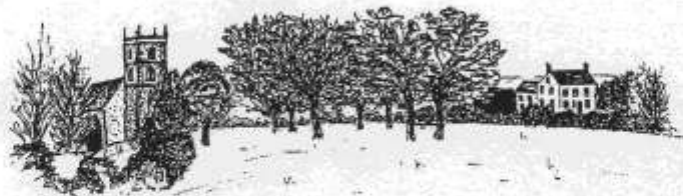
A fine view of St. Andrew's Church and Bleak House over Dovecot Yard.

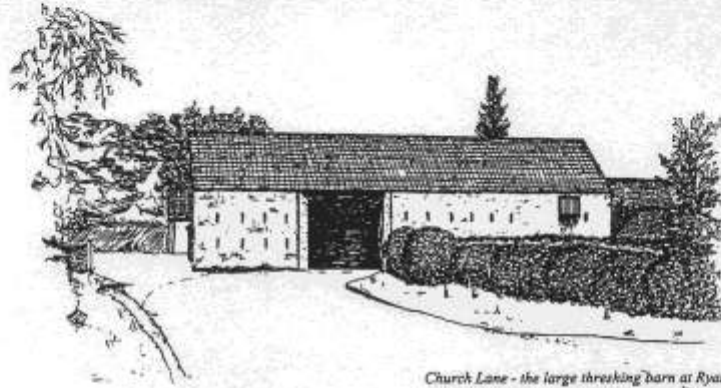
Church Lane - the large threshing barn at Ryalls Farm makes a striking stop to the view.

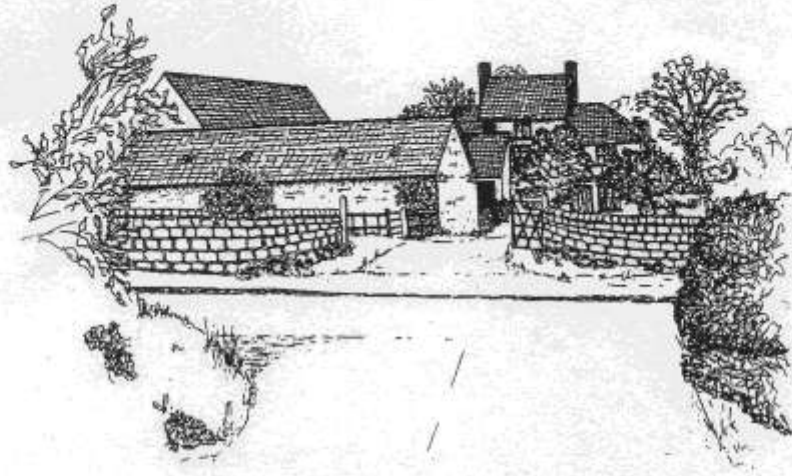
Pond Farm, Kirklington Road - a very attractive collection of traditional farm buildings.

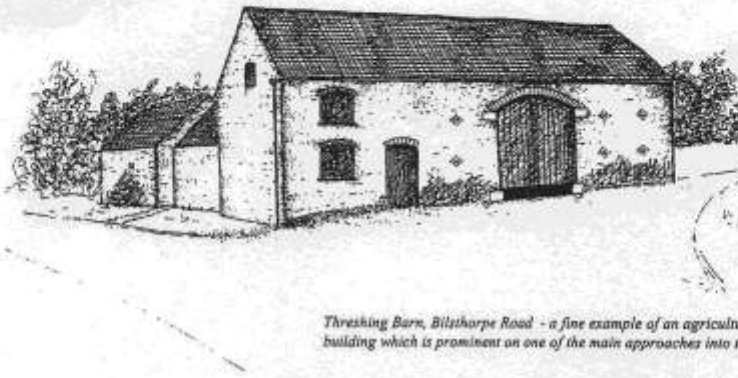
Threshing Barn, Bilthorpe Road - a fine example of an agricultural building which is prominent on one of the main approaches into the village.

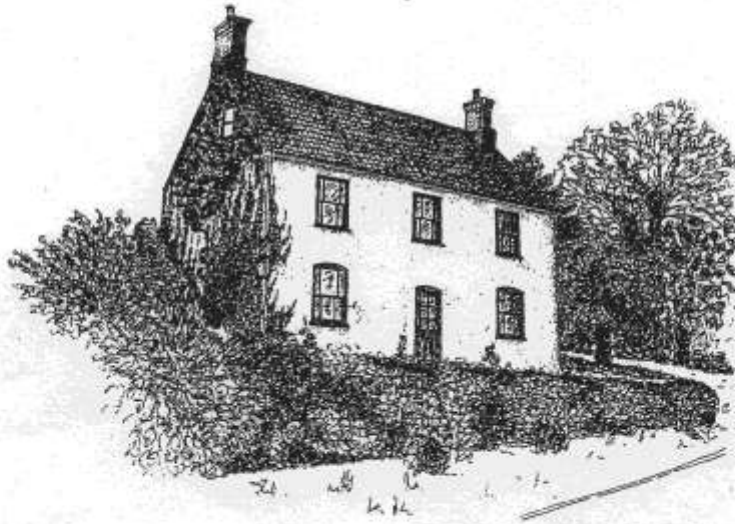
Hollies Farm, Main Street showing the symmetrically arranged windows, gable chimney stacks and pantile roof.

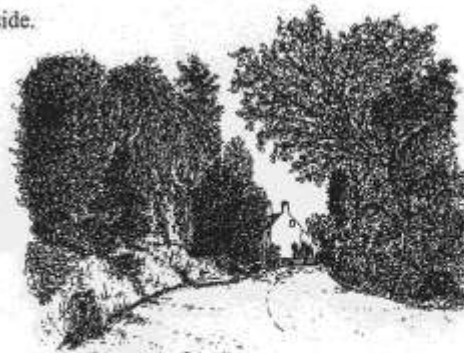
The road gently curves from Newark, the banks hedges and trees producing a corridor effect, gradually Hall Farm fills the view.

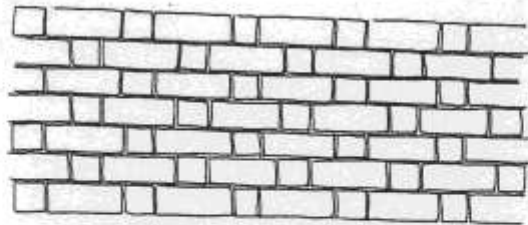
11. **Flemish bond brickwork.** Flemish bond brickwork, with alternate longways ("stretchers") and endways ("headers") bricks in each course, was often used for house fronts, often in conjunction with a pale superior quality mortar. The mortar joints were sometimes "penny struck", i.e. grooved down the middle to give a sharper and crisper appearance. Flemish bond brickwork was expensive to lay, so cheaper bonding patterns with less headers were usual on side and rear elevations. The bricks and mortar would often be less fine than on the front, and the pointing might be less carefully finished.
